**Flood Control Project Maintenance
Levee Inspections**

Fall 2009 Levee Maintenance Deficiency Summary Report

Reclamation District No. 1601 Twitchell

Waterway			Bank	Unit Miles
Unit No. 01 Threemile Slough			Left	2.47

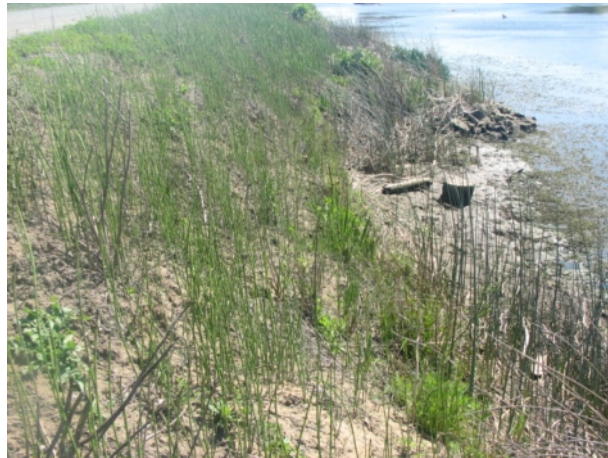
richard_20091110_108.jpg

Levee Mile Report Line	1
Start Levee Mile	0.20
End Levee Mile	0.25
Location	Water Side
Category	Earthen Levee
Item	Erosion / Bank Caving

Looking downstream at erosion site

LMR No	Levee Mile		Category	Item	Location *	Rating **	Action/Comment	GPS Latitude/Longitude		Issue No.
	Start	End						Start	End	Photo
1	0.20	0.25	Earthen Levee	Erosion / Bank Caving	WS	M	Note and monitor erosion site.	38.119517 ° -121.682907 °	38.118767 ° -121.682907 °	3 Y

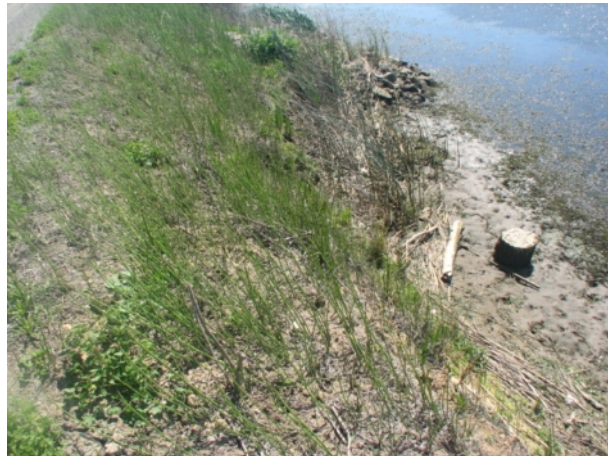
richard_20091110_109.jpg

Levee Mile Report Line	1
Start Levee Mile	0.20
End Levee Mile	0.25
Location	Water Side
Category	Earthen Levee
Item	Erosion / Bank Caving

Looking from the top of the levee at erosion site.

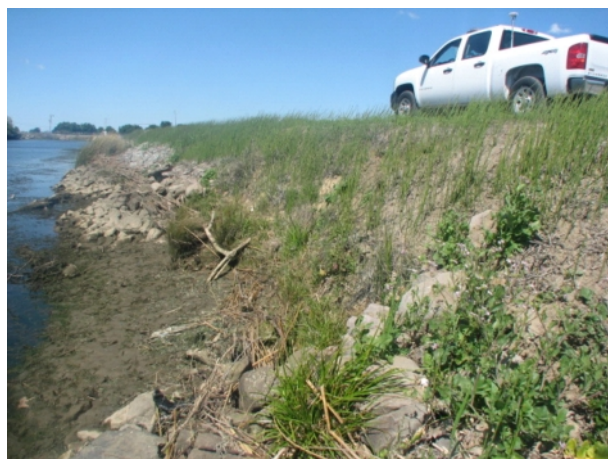
richard_20091110_110.jpg

Levee Mile Report Line	1
Start Levee Mile	0.20
End Levee Mile	0.25
Location	Water Side
Category	Earthen Levee
Item	Erosion / Bank Caving

Looking upstream at second erosion site.
